Manhole Inspection Summary

Manhole # S23EE1005MH

Location Address: **3920 BUENA VISTA AVE**

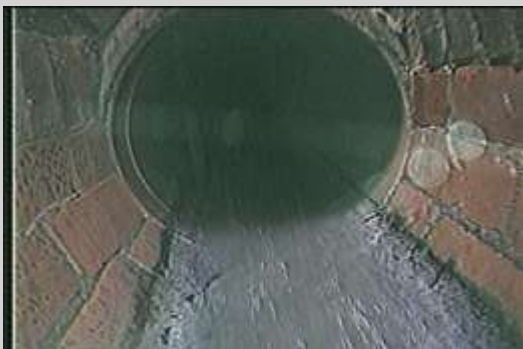
12 in. Circular Gravity Sewer Pipe In @ 6 O'Clock

Rod and Bar (Angled)

Infiltration: **None** Pipe Seal Cond: **Unknown**
